# HIGH ENERGY BEAM IMPACT TESTS ON A LHC TERTIARY COLLIMATOR AT CERN HIRADMAT FACILITY\*

M. Cauchi<sup>†</sup>, CERN, Geneva, Switzerland and University of Malta, Msida, Malta O. Aberle, R.W. Assmann<sup>‡</sup>, A. Bertarelli, F. Carra, A. Dallocchio, D. Deboy, S. Redaelli, A. Rossi, B. Salvachua, CERN, Geneva, Switzerland L. Lari, CERN, Geneva, Switzerland and IFIC (CSIC-UV), Valencia, Spain P. Mollicone, N. Sammut, University of Malta, Msida, Malta

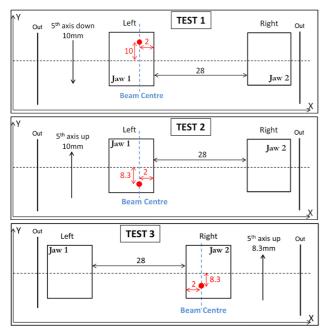
Figure 2: Schematic diagrams for Test 1, Test 2 and Test 3. The impact location is shown in red and all dimensions are in mm.

As indicated in Fig. 2, all tests were performed at an impact parameter of 2 mm in order to ensure that the jaw
